Federal Way City Center Access Project Cultural Resources Technical Report

Submitted to: Washington State Department of Transportation

Submitted by: Historical Research Associates, Inc. Matthew Warren, PhD Chrisanne Beckner, MS

> Seattle, WA December 2022

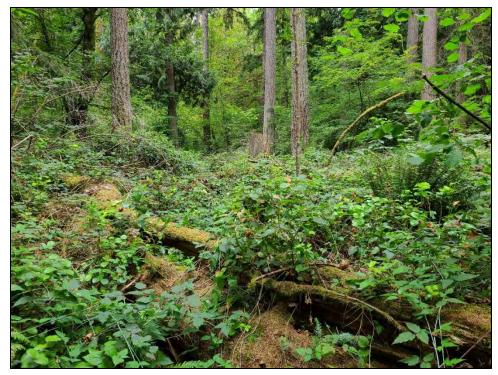
Figure 7.1-1. Representative example of disturbed secondary forest terrain present in different portions of the ADI; note the presence of dense understory vegetation and tree deadfall.

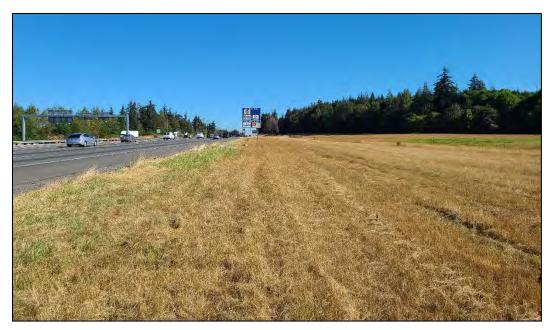
Figure 7.1-2. Maintained grass field setting along the east side of I-5 near the south end of the ADI, view north.

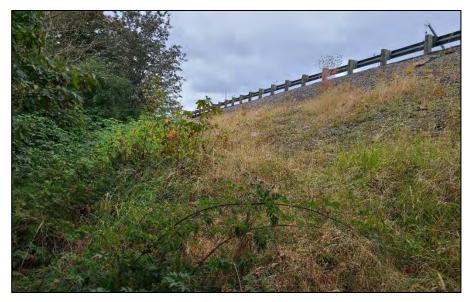
Figure 7.1-3. Example of the steep road prism of I-5 along its east side near the north end of the ADI, view southwest.

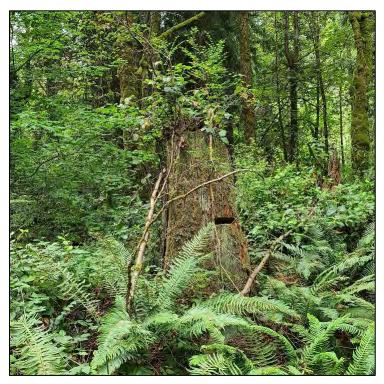
Two springboard-notched tree stumps were observed during the pedestrian survey but not recorded as archaeological resources (Figure 7.1-4), as such features are ubiquitous across western Washington. Abundant modern garbage consisting primarily of plastic wrappers and glass bottles was observed throughout the ADI.

Figure 7.1-4. Springboard-notched stump observed within the easternmost portion of the ADI.

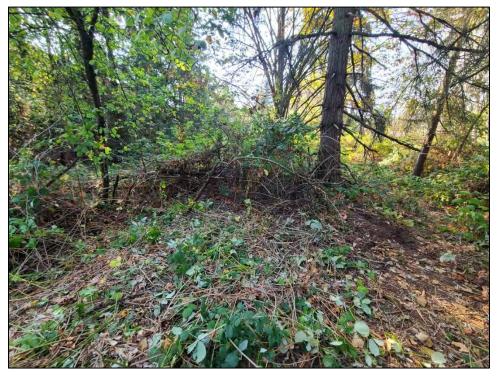
One archaeological resource, assigned the Smithsonian trinomial 45KI1662, was recorded in a narrow, vegetated area within the ADI during the survey. The site consists of a segment of mostly buried, degraded asphalt road surface approximately 15 ft wide (Figure 7.1-5). The road surface runs directly beneath a modern road at its north end at a depth of approximately 6 inches below the modern road surface and extends approximately 150 ft to the south, where it terminates at its intersection with a drainage canal that parallels the course of I-5 and varies in depth between approximately 1 and 3 ft. Most of the road surface is shallowly buried under a thin O horizon at a depth of up to 6 inches and has been disturbed since its abandonment by the extensive root systems of trees growing on and adjacent to it. Tree roots growing beneath it have forced portions of the asphalt road above the surrounding ground surface in several locations (Figure 7.1-6). While the depth of the roadbed was not evident, the asphalt layer was determined to be up to 1 inch thick. Site maps are included in the archaeological site form (Appendix E).

Figure 7.1-5. Buried asphalt road surface of Site 45KI1662, view south along site alignment.

On the basis of the criteria outlined in Section 6.3, HRA recommends archaeological site 45KI1662 not eligible for listing in the NRHP.

Site 45KI1662 is heavily deteriorated from abandonment, lack of maintenance, and the extensive growth of trees and shrubs on and adjacent to it since its abandonment. The site retains integrity of location and materials from its period of construction circa 1936–1949. However, other aspects of integrity necessary to be eligible for listing in the NRHP have been significantly compromised since its abandonment and subsequent degradation as secondary forest vegetation grew on and around it, including its integrity of design, setting, workmanship, feeling, and association. As the site does not meet NRHP criteria and has suffered an irretrievable loss of integrity, it is recommended as not eligible for listing in the NRHP.

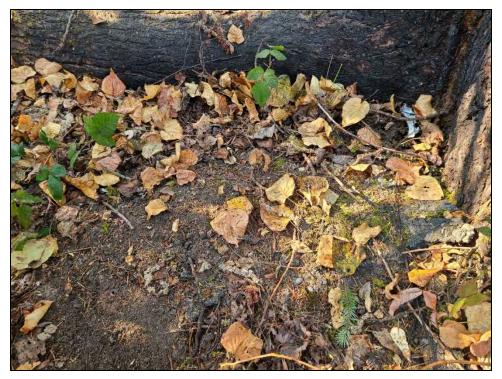
Figure 7.1-6. Asphalt road surface of Site 45KI1662 exposed due to root growth disturbance.

Historic maps of the local area indicate that the original north–south alignment of the road was constructed between 1936 and 1949. This segment of the road was in use until at least 1955 (Metsker 1936; Thomas Bros. 1955; USGS 1949). It was evidently abandoned during the construction of I-5, which opened to the public in 1962 (Stein 2003). The new interstate's road prism overlay most of the abandoned road segment and it does not appear on a 1961 USGS map (USGS 1961). Therefore, Site 45KI1662 is identified as a portion of this abandoned road segment. The present-day road surface at the north end of the site appears to directly overlay up to approximately 75 ft of the original alignment.

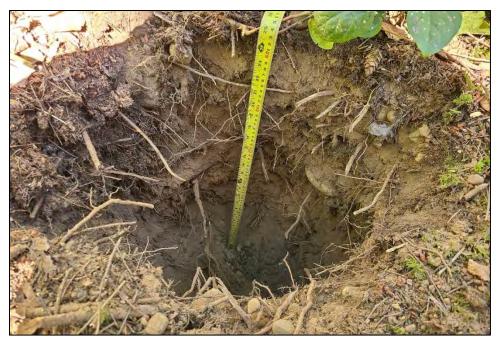
HRA archaeologists excavated 75 SPs within the portions of the ADI suitable for archaeological survey, all of which were negative for precontact and historic-period cultural materials (Appendix B). The sediments observed in the SPs excavated within the disturbed secondary forest settings generally consisted of an A horizon of dark brown to light grayish-brown silty loam to silty finegrained sand, which contained few to some rounded and subrounded gravels ranging from small pebbles to small cobbles, as well as many shrub and tree roots. The A horizon sediments were often overlaid by a thin layer of brown organic duff. Sediments underlying the A horizon generally consisted of light brown, yellowish-brown, or light grayish-brown fine-grained silt to silty finegrained sand containing few to many rounded to subangular gravels ranging from small pebbles to small cobbles and variable quantities of fine to medium sized tree roots (Appendix C; Figure 7.1-7).

Figure 7.1-7. Overview of typical soil profile within most of the ADI (disturbed secondary forest setting).

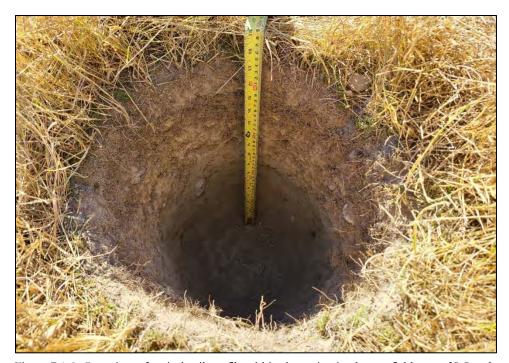
The sediments observed in the SPs located in the maintained grass field east of I-5 and north of South 336th Street generally consisted of a deeper A horizon of light gray to light brown densely compacted silt to fine-grained sandy silt containing some to many rounded to subangular gravels ranging from small pebbles to small cobbles and some fine grass roots. Beneath the A horizon, sediments typically consisted of light gray to gray densely compacted silt containing some to many rounded and subrounded gravels ranging from small pebbles to small cobbles, and some redoximorphic features throughout (Figure 7.1-8). The water table was not reached in any of the SPs.

Figure 7.1-8. Overview of typical soil profile within the maintained grass field east of I-5 and north of S $336^{\rm th}$ St.

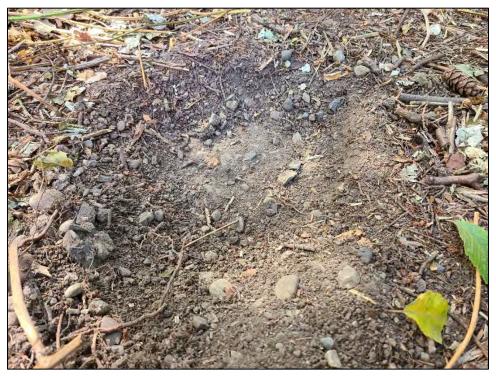
A small quantity of modern or temporally nondiagnostic waste debris was observed within one of the SPs (SP 19), while the buried asphalt road surface of Site 45KI1662 was encountered in another SP (SP 72) at 7 cmbs (Figure 7.1-9). No precontact or ethnographic-period cultural materials were identified during the subsurface survey.

Figure 7.1-9. Asphalt road surface of Site 45KI1662 exposed in SP 72.

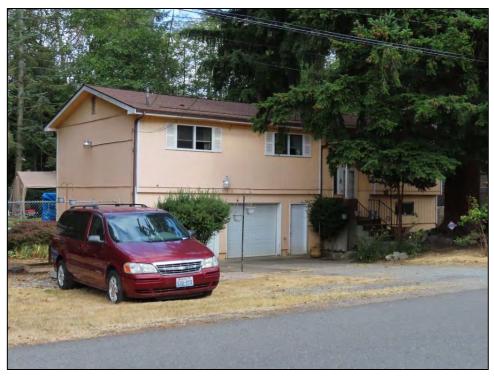
According to the King County Assessor, the residence at 2238 South 333rd Street was constructed in 1968 (King County Assessor 1935–2022). The two-story building faces south toward South 333rd Street. It is rectangular in plan, sits on a poured-concrete foundation, is clad in T1-11, and is topped by a side-gabled roof covered in asphalt shingles (Figures 7.2-1–7-2.3).

The building's facade includes a concrete stair with wrought iron rails leading to an off-center entry door paired with a full-height sidelight to the west. A rectangular window is located above the door and under a roof projection supported by a simple square column. West of the entry are a pair of vinyl-frame sliding windows with inoperable shutters. East of the entry is a slight projection with a central picture window above vinyl-frame sliders. The window is flanked by inoperable shutters. The building's lower level includes two overhead garage doors and a pedestrian door on the west half and a centrally located sliding window on the east half. The building's east elevation includes an exterior, concrete-block chimney. The building's west elevation includes no fenestration. To the rear of the residence are two garden sheds, minimally visible, and a small greenhouse.

Figure 7.2-1. 2238 South 333rd Street, view northeast.

From its period of construction (1968), the residence at 2238 S 333rd St. retains integrity of location, setting, feeling, and association, as it remains a single-family residence on its original parcel. The building's windows have been replaced with incompatible vinyl-frame windows and framed with shutters. The building does not retain integrity of design, materials, or workmanship.

Due to a lack of significance and diminished integrity, HRA recommends 2238 South 333rd Street not eligible for listing in the NRHP under any criteria.

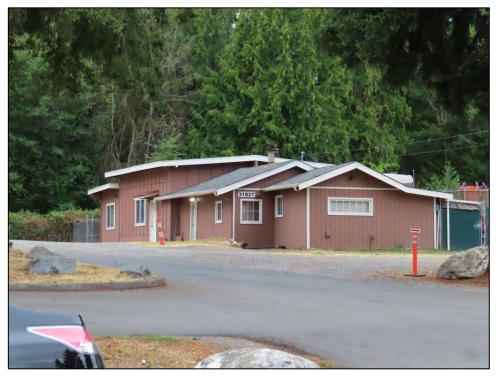
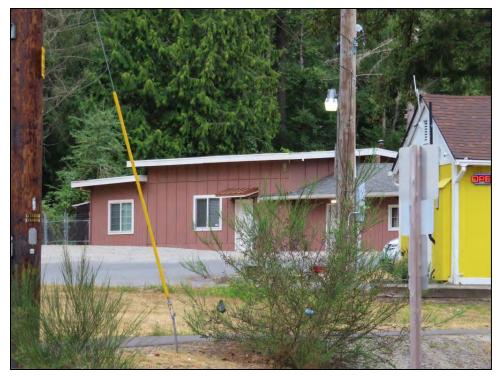
According to the King County Assessor, the former residence at 31827 Military Road South was constructed in 1943 (King County Assessor 1935–2022). It has been converted to office use. The office building faces south and is irregular in plan. Its sits on a poured-concrete foundation and is clad in a combination of board-and-batten (central mass) and T1-11 (projections north and south. The building is topped by a steep side-gabled roof with projecting eave (central mass) with a steep side-gabled roof on the eastern projection, and a shallow side-gabled roof on the west projection. The roof is covered in asphalt shingles (Figures 7.2-4–7-2.6).

The building's central mass includes a pedestrian door under a small, projecting hood. A vinyl-frame sliding window is located to the east. To the west of the central mass is a tall garage with an additional vinyl-frame sliding window. To the east of the central mass are two stepped-back projections including a single pedestrian door and four-light, wood-frame windows. On the eastfacing elevations, windows include a six-light, square, wood-frame window and a wide five-light, wood-frame window. No other fenestration is evident. The building's north elevation is screened from view by chain-link fence.

From its period of construction (1943), the office at 31827 Military Road South retains integrity of location, as it remains on its original parcel. Multiple additions, the first of which added an office to the former residence (east) and the second of which added a large garage off the original residence (west), led to an irretrievable loss of integrity by 1983 (King County Assessor 1935–2022). Additionally, the residence has been converted from a residential to commercial use, its windows and siding replaced, and its large parcel altered by the demolition of former buildings and the construction of a drive-thru coffee stand. Alterations and additions, along with a change of use, have diminished the building's integrity of setting, design, materials, workmanship, feeling, and association.

Due to a lack of significance and an irretrievable loss of integrity, HRA recommends 31827 Military Road South not eligible for listing in the NRHP under any criteria.

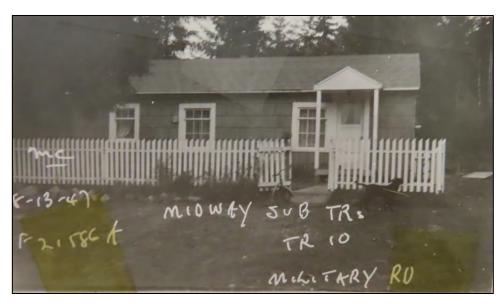
Figure 7.2-6. 31827 Military Road South, 1947, King County Assessor, courtesy of the Puget Sound Regional Branch of the Washington State Archives.

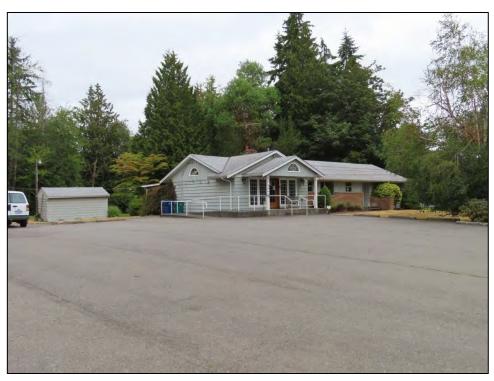
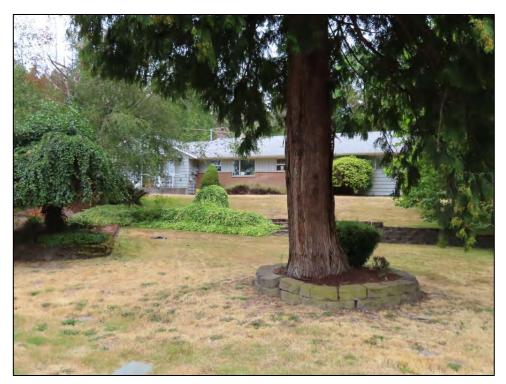
According to the King County Assessor, the former residence at 3820 South 320th Street, which has been converted to a commercial use, was constructed in 1957 (King County Assessor 1935–2022). The parcel includes a large, freestanding, roadside sign for "Poole Pain Relief and Wellness Center." The building faces south on a large parcel with an expansive, paved parking lot to the south, shared with the neighboring residence at 3810 South 320th Street. The commercial building sits on a poured-concrete foundation, is clad in lapped boards with a skirt of brick veneer, and is topped by a side-gabled roof with asphalt shingles (Figures 7.2-7–7.2-9).

The building's facade includes a projecting gabled entry. A central pedestrian door is flanked east and west by pairs of full-height, vinyl-frame windows. The porch, with pipe rail and concrete ramp, shelters under a projecting gable clad in T1-11 with a vinyl fan light. East of the projecting entry, the elevation includes aluminum-frame fixed and casement windows. The building's west elevation includes T1-11 and a fan light in the gable. Other elevations were not visible.

From its period of construction (1957), the office building at 3820 South 320th Street retains integrity of location, as it remains on its original parcel. A change of use (from residential to commercial), plus the addition of a projecting entry on a former garage, commercial signage, replacement windows, and paved parking area, along with alterations in fenestration patterns, have diminished its integrity of setting, design, materials, workmanship, feeling, and association.

Due to a lack of significance and an irretrievable loss of integrity, HRA recommends 3820 South 320th Street not eligible for listing in the NRHP under any criteria.

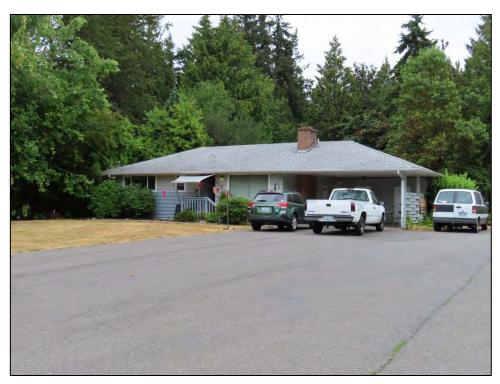
According to the King County Assessor, the residence at 3810 South 320th Street was constructed in 1957 (King County Assessor 1935–2022). The building is rectangular in plan, sits on a pouredconcrete foundation, is clad in lapped wood boards, and is topped by a side-gabled roof covered in asphalt shingles. The building shares a large, paved parking area with the neighboring office building at 3820 South 320th Street (Figures 7.2-10-7.2-12).

The building's south-facing facade includes an off-centered entry with a small stoop and wood railing. West of the entry are vinyl-frame one-over-one and casement windows. East of the entry is a large picture window and a brick planter box. East of the planter box is a recessed carport. Under the projecting carport roof is an exterior brick chimney and doors at the rear, presumably to access storage areas. East of the carport is a partial screened wall.

Figure 7.2-10. 3810 South 320th Street, view northwest.

According to the present tenant, the residence has been recently altered by the addition of a large picture window on the facade (personal communication, 2022). From its period of construction (1957), the building at 3810 South 320th Street retains integrity of location, feeling, and association, as it remains a single-family residence on its original parcel. However, the conversion of the neighboring building at 3820 South 320th Street to commercial use, the replacement of windows and window types, the addition of a porch with rail and awning, a screening wall on the carport, and paved parking have diminished the residence's integrity of setting, design, materials, and workmanship.

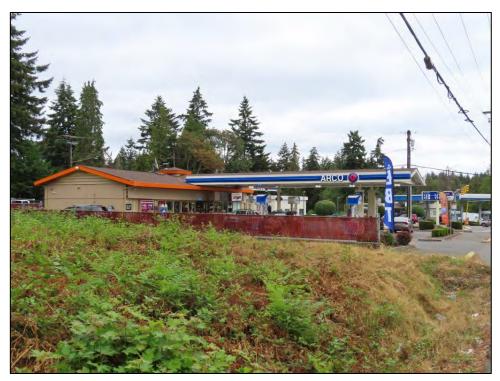
The building's facade includes a central aluminum-frame entry door flanked by windows to the east and west. The western windows are wood frame. The eastern windows are metal frame. All are topped by a panel for signage that reads "am/pm." The shallow gable roof includes a central monitor and gabled projections over walkways and gas pumps. The building's secondary elevations include no fenestration. It appears that former windows may have been covered. Freestanding signs and projecting awnings identify the retailer as Arco. Gas pumps are located alongside columns supporting the projecting gabled awnings. The building's rear elevation includes pedestrian doors but no additional fenestration.

Figure 7.2-13. 3910 South 320th Street, view northeast.

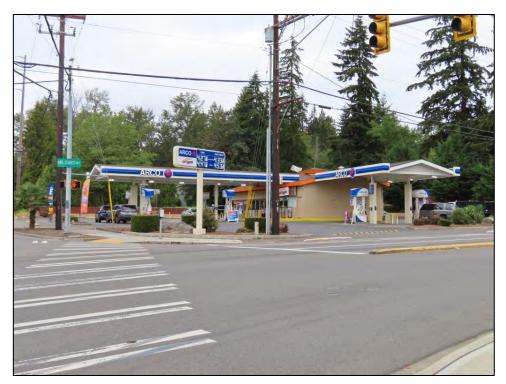
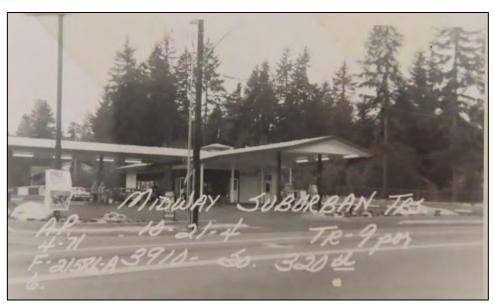
According to the King County Assessor, the gas station and market at 3910 South 320th Street was constructed in 1971 (King County Assessor 1935-2022). The rectangular building, with two projecting awnings over gas pumps off the south and east elevations, faces south. The building sits on a poured-concrete foundation and is clad in a mix of materials including board-and batten on the facade, stucco on the facade, and plywood panels topped by lapped wood boards on secondary elevations. The building is topped by a side-gabled roof covered in asphalt shingles (Figures 7.2-13– 7.2-15).

From its period of construction (1971), the gas station and market at 3910 South 320th Street retains integrity of location, setting, feeling, and association, as it remains on its original parcel at a busy intersection. Aerials and assessor's photos suggest the building and canopies retain their original forms. However, replacement windows, covered windows, sealed doors on the east elevation, a change of use from a service station to a market, and a mix of materials, suggesting additional alterations, have diminished its integrity of design, materials, and workmanship (King County Assessor 1935–2022).

Due to a lack of significance and loss of integrity, HRA recommends 3910 South 320th Street not eligible for listing in the NRHP under any criteria

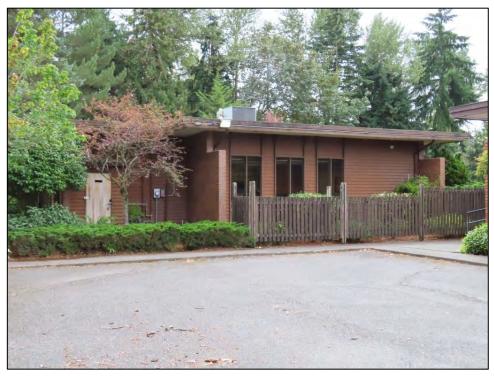
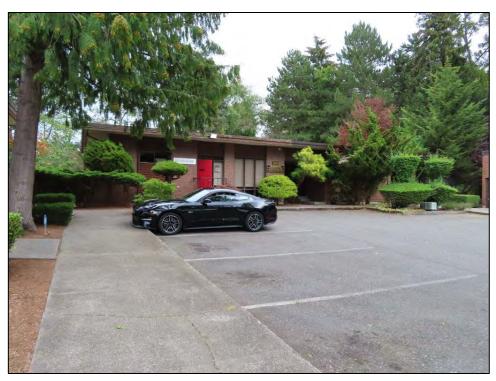
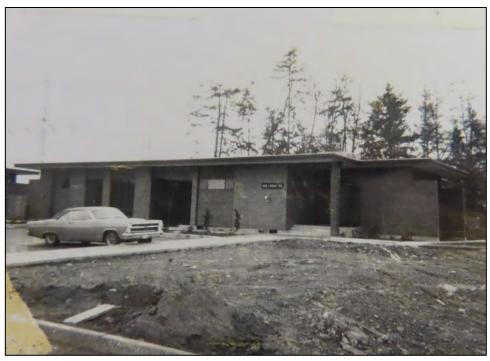
According to the King County Assessor, the business office at 1832 South 324th Place was constructed in 1974 (King County Assessor 1935–2022). The building sits at the rear (south) of a flag lot. It sits on a poured-concrete foundation; is constructed of concrete block, according to the King County Assessor; and is clad in a combination of lapped wood boards and brick veneer in running bond. The building is topped by a flat built-up roof with deep overhanging eaves. This building includes two units for healthcare-providing tenants (Figures 7.2-16–7.2-18).

The building's west elevation includes an entry and stoop near the north end and a recessed entry and stoop at the south, with a secondary entry located in a central alcove. Entries include single pedestrian doors with shallow stairs and stoops and pipe railings. Entry doors are paired with fullheight sidelights and transoms. Additional windows appear as shallow aluminum-frame windows above panels of lapped boards, or in groups of two and three narrow, tall, wood-frame windows.

The north elevation includes projecting end walls, a privacy fence, windows in groups of two, and a combination of siding materials, as well as a gate with door that may access a rear entrance or patio. Other elevations were not visible from the public ROW. The building's immediate grounds are heavily landscaped, providing screening for entries and interiors.

No alterations are evident, apart from a small number of aluminum-frame windows that may have replaced earlier wood-frame windows. From its period of construction (1974), the building at 1832 South 324th Place retains integrity of location, setting, design, materials, workmanship, feeling, and association.

Due to a lack of significance, HRA recommends 1832 South 324th Place not eligible for listing in the NRHP under any criteria

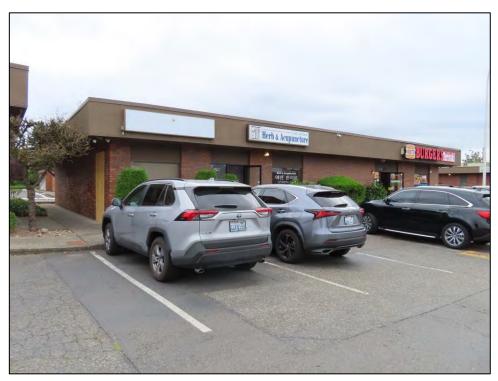
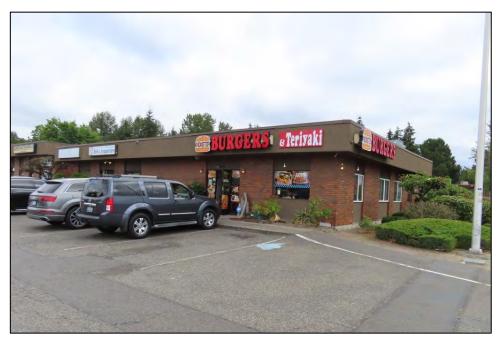
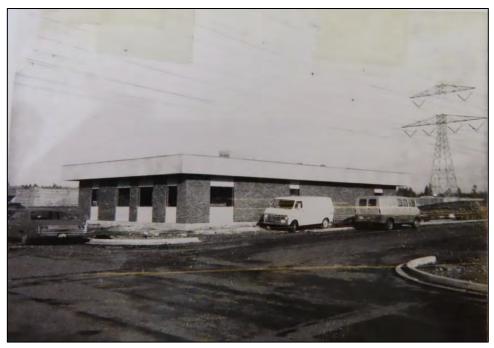
According to the King County Assessor, the commercial building at 1703 South 324th Street was constructed in 1974 among other commercial and professional buildings once known as "Federal Way Plaza South," although research revealed little about its original use (King County Assessor 1935–2022). The building is rectangular in plan and faces north. It sits on a poured-concrete foundation, is clad in running bond brick, and is topped by a flat, built-up roof with a heavy eave used for signage (Figures 7.2-19-7.2-21).

The building's facade has two entries. The eastern entry includes a metal pedestrian door paired with a full-height sidelight and topped by a panel of textured concrete (pebble dash). The entry door is paired east and west with metal-frame fixed lights, also located between panels of textured concrete. Marquis signage indicates the tenant is City of Joy Herb & Acupuncture. A second marquis sign is currently empty. The western entry includes a single metal pedestrian door flanked by full-height sidelights and topped by a panel of textured concrete. A metal-frame window to the west of the entry is located between textured-concrete panels. The marquis sign on the eave reads "Monster Burgers & Teriyaki." The building's western elevation includes four bays within a wall of brick, each

with vinyl-frame sliding windows located between panels of textured concrete. The rear (south) elevation includes two additional windows and a pedestrian door.

From its period of construction (1974), the commercial building at 1703 South 324th Street retains integrity of location and setting, as it remains a commercial building on its original parcel. Alterations including incompatible replacement windows and a change of use, from medical offices to commercial strip, have diminished its integrity of design, materials, workmanship, feeling, and association (King County Assessor 1935–2022).

Due to a lack of significance and diminished integrity, HRA recommends 1703 South 324th Street not eligible for listing in the NRHP under any criteria

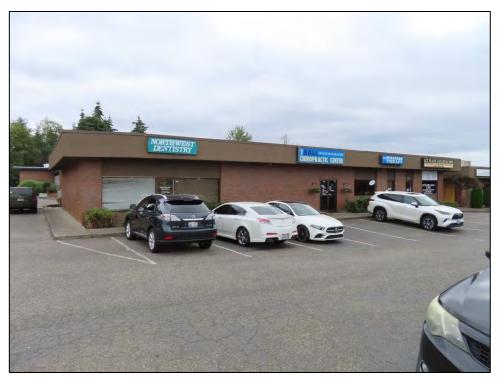
The building's facade includes storefront entries for three tenants. The eastern entry, for Northwest Dentistry, includes a metal pedestrian door flanked by large metal-frame picture windows. The entry is topped by a panel of textured concrete (parging). The central storefront includes one large metalframe window located between panels of textured concrete. The window is flanked to the east by paired, glazed pedestrian doors and to the west by a single glazed pedestrian door topped by textured concrete. Two marquis signs identify the tenant as "Ball Chiropractic Center" and "Massage Therapy." The western entry includes a single, glazed pedestrian door under a panel of parged concrete and one wide metal-frame window located between textured-concrete panels. A marquis sign identifies the tenant as "K.T. Hair Salon and Spa." The building's eastern and western elevations include no fenestration. The building's rear (south) elevation includes secondary entries for all three tenants, with two large windows on the east end and smaller square windows associated with the entries of the central and western businesses.

Figure 7.2-22. 1720 South 324th Place, view southwest.

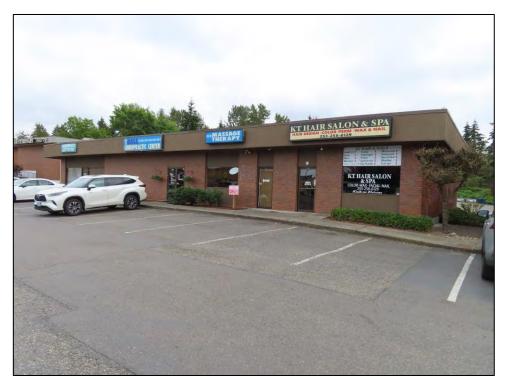
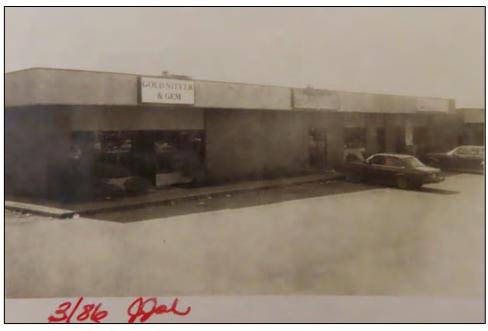
According to the King County Assessor, the commercial building at 1720 South 324th Place was constructed in 1975 (King County Assessor 1935–2022). The building is rectangular in plan and faces north. It sits on a poured-concrete foundation, is clad in running bond brick, and is topped by a flat, built-up roof with a heavy eave used for signage (Figures 7.2-22–7.2-24).

From its period of construction (1975), the commercial building at 1720 South 324th Place retains integrity of location, setting, design, materials, workmanship, feeling, and association, as the only evident alterations are related to tenant turn-over and do not impact the overall integrity of the building.

Due to a lack of significance, HRA recommends 1720 South 324th Place not eligible for listing in the NRHP under any criteria

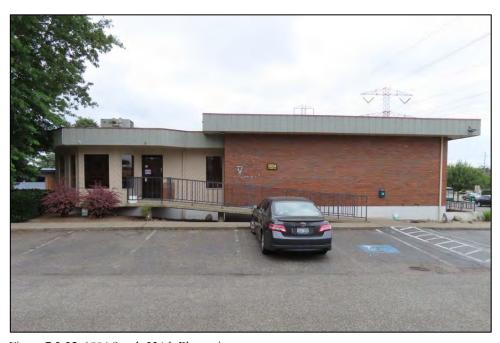
The building is constructed of two distinct halves, a brick block to the north, with no fenestration, and a recessed, wood-clad office to the south with oriel window. The building's east-facing facade includes an off-center entry, accessed by a concrete ramp with metal railing. The entrance door is flanked to the south by the building's large, irregular oriel window with fixed, wood-frame windows. To the north is an additional fixed window and the northern projection, entirely clad in brick veneer. Likewise, the building's north elevation includes a wall of brick with no fenestration. A marquis sign reads "Cascade Veterinary Hospital." The building's west elevation includes a wall of brick, plus a secondary entry on the southern, wood-clad office. An exterior stair with open concrete treads, leads to a single pedestrian door paired with a square wood-frame window between plywood panels. The building's south elevation includes the projecting walls of the irregular oriel and wood-framed windows.

Figure 7.2-25. 1804 South 324th Place, view west.

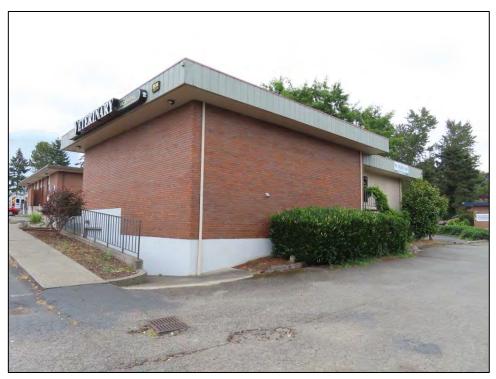
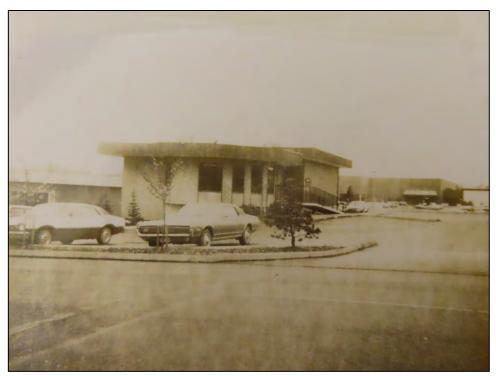
According to the King County Assessor, the commercial building at 1804 South 324th Place was constructed in 1976 (King County Assessor 1935–2022). The building is a single story, irregular in plan, and faces east. It sits on a poured-concrete foundation, is clad in a combination of brick in running bond and diagonal boards, and is topped by a flat, built-up roof with deep projecting eave (Figures 7.2-25–7.2-27).

From its period of construction (1976), the commercial building at 1804 South 324th Place retains integrity of location, setting, design, materials, workmanship, feeling, and association, as no alterations are evident.

Due to a lack of significance, HRA recommends 1804 South 324th Place not eligible for listing in the NRHP under any criteria.

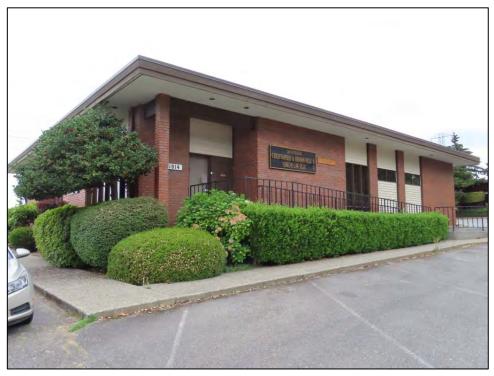
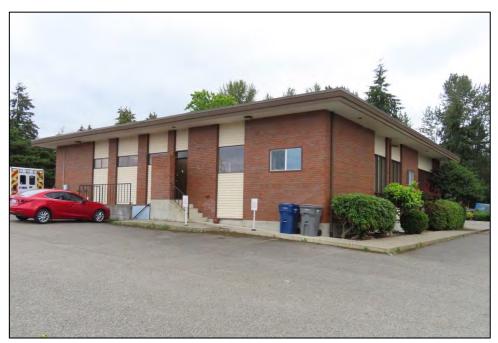
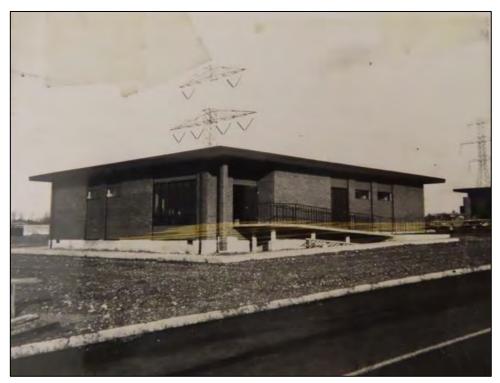
According to the King County Assessor, the commercial office building at 1814 South 324th Place was constructed in 1974 (King County Assessor 1935–2022). The building is square in plan and faces south. It sits on a poured-concrete foundation, is clad in a combination of brick in running bond and horizontal, lapped boards, and is topped by a flat, built-up roof with eaves (Figures 7.2-28-7.2-30).

The building's south-facing facade includes a ramp with metal railing leading to a recessed entry at the southwest corner consisting of a single glazed door paired with a full-height sidelight. The entry is topped by a panel of lapped boards. To the east of the entry is a wall of brick with a sign for the Law Offices of Christopher A. Benson PLLC Adkins Law PLLC. To the east of this wall are three bays including metal windows and panels of lapped boards. The building's east elevation also includes bays of windows, separated by brick and located between panels of lapped boards. An offcenter entry door includes a projecting awning topped by a panel of lapped boards. The building's north elevation includes an exterior concrete stair with brick screen and panels of metal-frame sliding and fixed windows between panels of lapped boards. A vinyl-frame window has been added to the elevation's northwest corner. The building's west elevation includes two bands of tall

windows between panels of lapped boards. A vinyl-frame sliding window has been added to the brick wall between them.

Based on its period of construction (1974), the office building at 1814 South 324th Place retains integrity of location, setting, feeling, and association, as it remains an office building on its original parcel. Alterations including the addition of vinyl-frame windows within previously solid walls on two elevations, added between 2015 and 2021, as indicated by King County Assessor, have diminished its integrity of design, materials, and workmanship (King County Assessor 1935–2022).

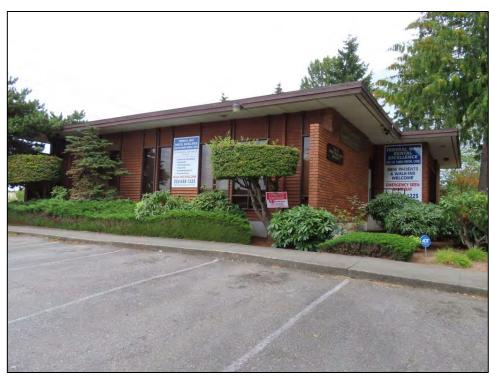
The building's south-facing facade includes a recessed entry with shallow concrete stoop and metal railing. The entry door, an incompatible door with oval light, is flanked by a full-height sidelight to the west and is topped by a shallow transom topped by a panel of lapped boards. The entry is flanked to the east by a projection with a ribbon of wood-frame windows between panels of lapped boards. Applied signage identifies the tenant as Federal Way Dental Excellence. The building's southeast corner steps back, providing a walkway between this building and the neighboring building at 1832 S 324th Pl. The building's secondary west elevation includes projecting end wall and windows, singular or in pairs, with projecting wood frames. Between them are panels of lapped boards. The building's north elevation includes two secondary entries behind projecting brick screens, both with shallow concrete stairs and metal railings. Between the two entries are windows, singular and in pairs, with projecting wood frames in walls of lapped wood boards. A small utility or storage bay, brick clad, is located at the building's northwest corner. The building's east elevation also includes projecting brick endwalls and windows in pairs or singular, with projecting wood frames in a wall of lapped boards.

Figure 7.2-31. 1826 South 324th Place, view northeast.

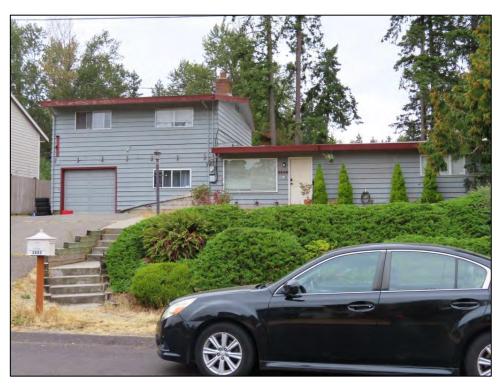
The building's south-facing facade includes an off-center entry on the east half. The entry door is paired with a large, vinyl-frame picture window. Near the building's southeast corner is an aluminum-frame fixed window with adjacent casement. The building's west, two-story mass includes an overhead garage door and a vinyl four-light window on the lower floor, the braces for a former balcony above them, and two aluminum-frame windows on the second floor. Secondary elevations are minimally visible behind mature foliage, but no fenestration was visible.

Figure 7.2-34. 3802 South 321st Street, view north

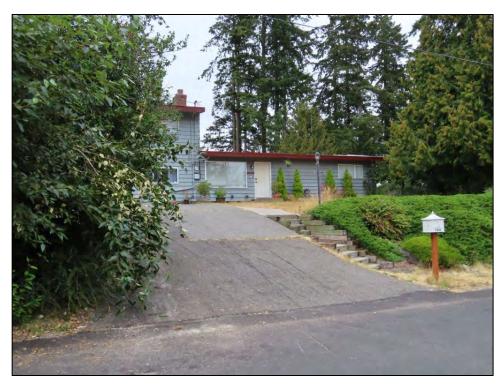
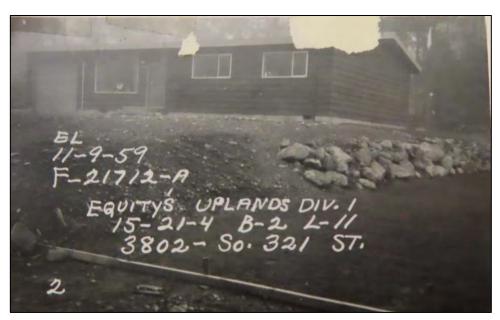
From its period of construction (1959), the residence at 3802 South 321st Street retains integrity of location, setting, and association, as it remains a single-family residence on its original parcel. However, the building has been greatly enlarged by a second-story addition over a reconfigured garage, and additional alterations including incompatible vinyl windows, the boarding up of a former window near the entry door, and the removal of a former balcony above the garage, have further diminished its integrity of design, materials, workmanship, and feeling (King County Assessor 1935– 2022).

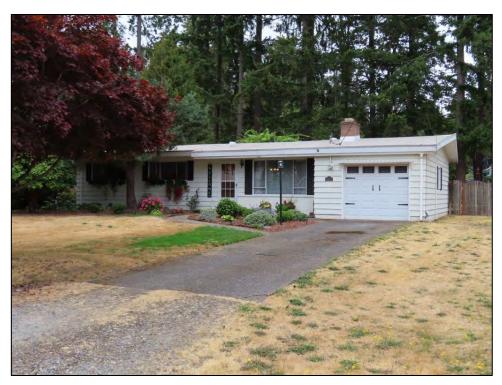
The building's facade includes a central entry door with small concrete stoop, sheltering under a projecting eave. The entry door is flanked to the west by two wood-frame windows with inoperable shutters. The entry is flanked to the east by a large three-part picture window over a skirt of brick veneer. Windows are wood frame. To the east of the window is a projecting garage with overhead garage door. A shallow wood awning is located above the garage door. The building's secondary east and west elevations were minimally visible but include additional wood windows and a slightly projecting roof peak.

Figure 7.2-37. 3812 South 321st Street, view northwest.

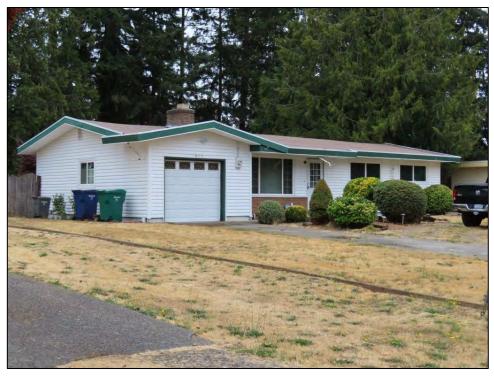
The building's south-facing facade includes a central entry with concrete stoop under a slight roof projection. The entry is flanked to the east by two vinyl-frame sliding windows, and to the west by a large three-part vinyl-frame picture window over a skirt of brick veneer. To the east is a projecting garage with front-gabled roof and overhead garage door. According to the King County Assessor, the building has been enlarged from 1,008 square ft to 1,610 square ft by an addition to the rear and a second addition deeply set back off the building's northeast corner, where it is obscured by mature foliage (King County Assessor 1935–2022). Secondary elevations include additional vinyl windows.

Figure 7.2-40. 3820 South 321st Street, view northeast.

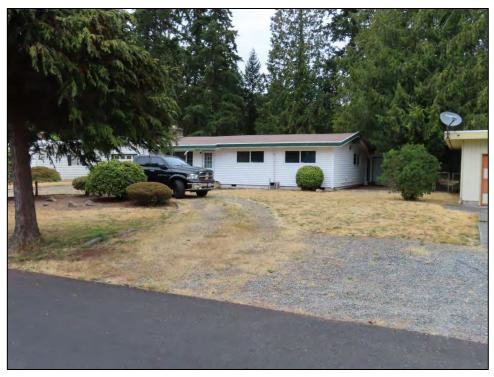
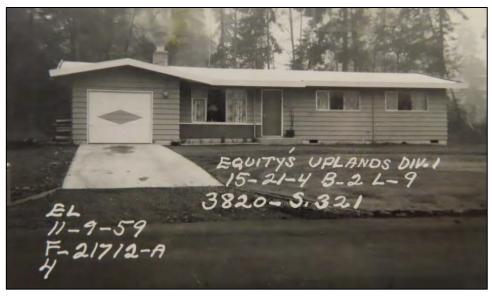
From its period of construction (1959), the residence at 3820 South 321st Street retains integrity of location, setting, feeling, and association, as it remains a single-family residence on its original parcel. Additions to the rear and to the east, along with incompatible materials including vinyl siding and windows, have diminished its integrity of design, materials, and workmanship (King County Assessor 1935–2022).

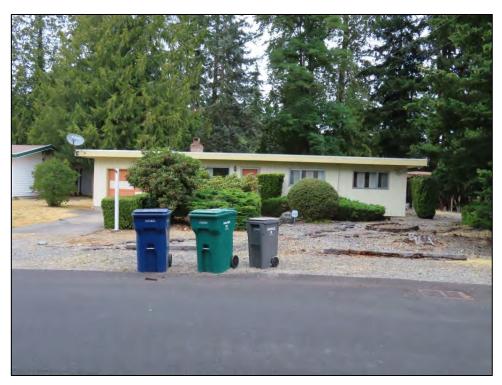
The building's south-facing facade includes a central entry door with shallow stoop flanked east and west by aluminum-frame windows. At the facade's west end is an attached garage with a woodpaneled, overhead garage door. Side elevations include no evident fenestration or other features.

Figure 7.2-43. 3828 South 321st Street, view north.

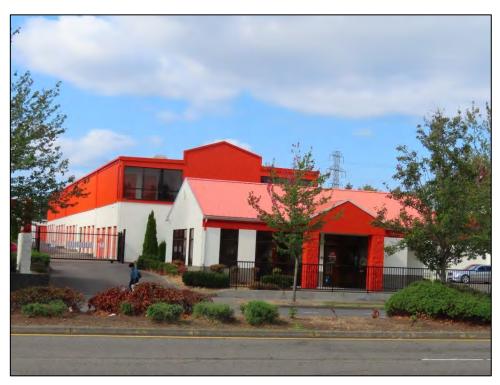
The warehouses are consistent, featuring overhead garage doors facing the interior of the complex. The office building includes a projecting gable at the entry, supported by concrete-block columns. Windows on the facade and on secondary elevations are tall and metal frame. On the north elevation, the building's mass is cut away to provide a covered walkway to a metal-frame entry door flanked by metal-frame windows. To the rear of the office, the large warehouse includes an eastfacing parapet flanked north and south by full-height metal-frame windows.

Figure 7.2-46. 32615 Pacific Highway South, view northwest.

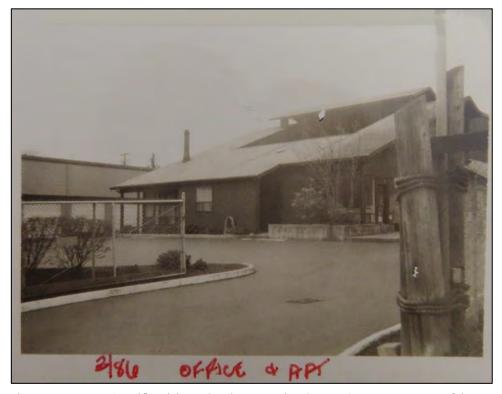
Figure 7.2-48. 32615 Pacific Highway South, 1986, King County Assessor, courtesy of the Puget Sound Regional Branch of the Washington State Archives.

From its period of construction (1975), the warehouse complex at 32615 Pacific Highway South retains integrity of location and setting, as it remains on its original parcel on Pacific Highway South. The complex does not retain integrity of design, materials, workmanship, feeling, or association due to extensive alterations and additions that included the replacement of the original office building ca. 2006 (King County Assessor 1935–2022; NETROnline 2022).

Due to a lack of significance and irretrievable loss of integrity, HRA recommends 32615 Pacific Highway South not eligible for listing in the NRHP under any criteria.

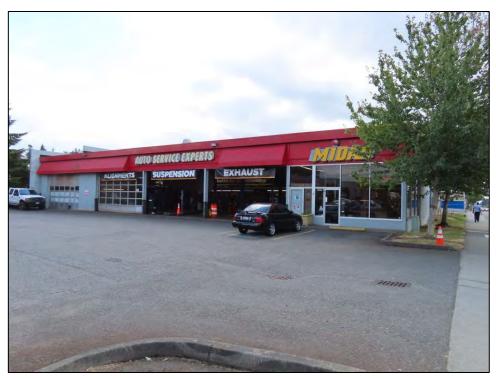
The building's facade includes an aluminum-frame pedestrian door surrounded by aluminum-frame full-height windows and transoms that wrap the building's northwest corner. East of the entry is a secondary aluminum-frame door with sidelight and transom. Farther east are four garage bays with overhead garage doors. Visible garage doors are metal with lights. The garage bays are partially topped by shallow awnings, broken by a sign for "Auto Service Experts." The building's west elevation includes corner-wrapping windows near the entry but no other fenestration. The south elevation abuts another building and was not visible. The east elevation includes a projecting end wall but was not visible.

Figure 7.2-49. 32530 Pacific Highway South, view south.

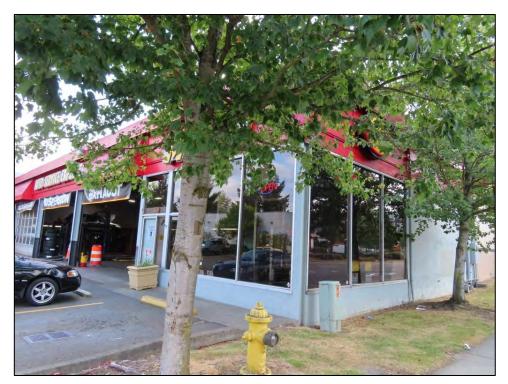
Figure 7.2-50. 32530 Pacific Highway South, view southeast.

According to the King County Assessor, the automotive service center at 32530 Pacific Highway South was constructed in 1975 (King County Assessor 1935–2022). The building is a single story tall, rectangular in plan, and faces a parking lot to the north. The building sits on a poured-concrete foundation, is constructed of concrete block, and is topped by a flat built-up roof with parapet (Figures 7.2-49–7.2-51).

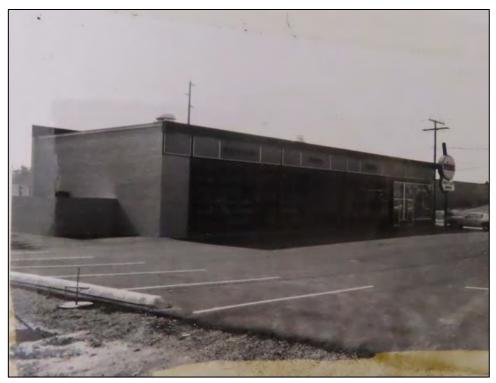
Figure 7.2-51. 32530 Pacific Highway South, undated, King County Assessor, courtesy of the Puget Sound Regional Branch of the Washington State Archives.

From its period of construction (1975), the building at 32530 Pacific Highway South retains integrity of location, setting, design, materials, workmanship, feeling, and association, as few alterations are evident apart from the replacement of one glass pedestrian door with a solid door and the removal of freestanding signage, evident in assessor's photos (King County 2022).

Due to a lack of significance, HRA recommends 32530 Pacific Highway South not eligible for listing in the NRHP under any criteria.

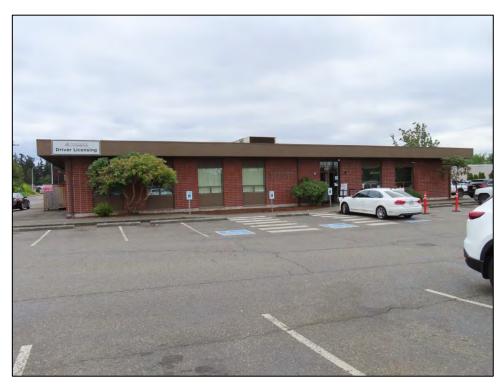
The building's north-facing facade includes an off-center entry door paired with metal-frame transom and full-height sidelight. East and west of the entry are metal-framed windows between panels of stucco or textured concrete. Windows are separated by stacked brick walls. Four are located east of the entry, and two are located to the west. The eave includes signage for the "Washington State Department of Licensing." The secondary west elevation includes seven metalframe windows between textured-concrete panels. The building's east elevation includes only one large window between textured-concrete panels. One pedestrian door, and two smaller windows with textured-concrete panels are also located on this elevation, along with a pad screened by a fence of wood boards. The rear (south) elevation includes nine windows with textured-concrete panels across the elevation, and a secondary entry door.

Figure 7.2-52. 1617 South 324th Street, view southwest.

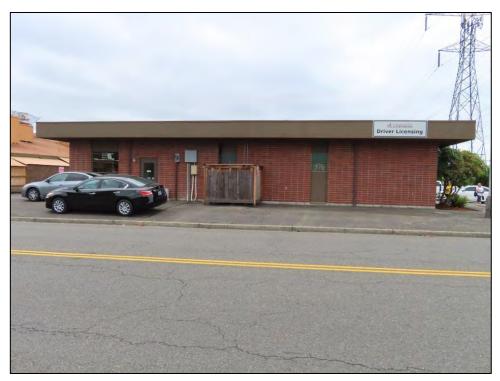
Figure 7.2-53. 1617 South 324th Street, view west.

According to the King County Assessor, the office building at 1617 South 324th Street was constructed in 1971 (King County Assessor 1935–2022). The building is square in plan, a single story tall, and faces north. It sits on a poured-concrete foundation, is clad in brick in stacked bond, and is topped by a flat built-up roof with deep eave (Figures 7.2-52–7.2-54).

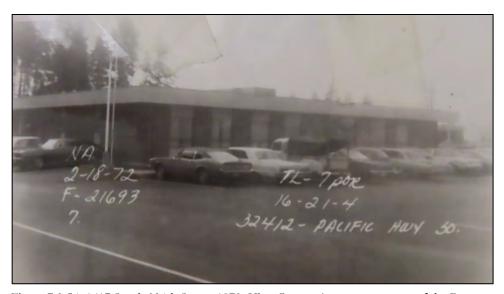
Figure 7.2-54. 1617 South 324th Street, 1972, King County Assessor, courtesy of the Puget Sound Regional Branch of the Washington State Archives.

From its period of construction (1971), the building at 1617 South 324th Street retains integrity of location, setting, design, materials, workmanship, feeling, and association, as no alterations were evident, apart from some in-kind window replacement.

Due to a lack of significance, HRA recommends the offices at 1617 South 324th Street not eligible for listing in the NRHP under any criteria.

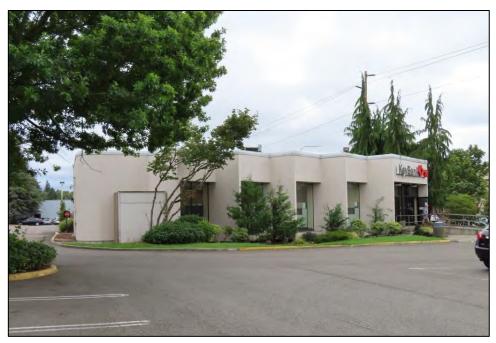
Figure 7.2-55. 32400 Pacific Highway South, view southwest.

According to the King County Assessor, the bank building at 32400 Pacific Highway South was constructed in 1974 (King County Assessor 1935–2022). It was designed by Callison, Erickson and Hobble and constructed by Universal Builders for the Continental Bank of Federal Way (Seattle Times 1973). The building is a single story tall, irregular in plan, with a telescoping facade facing north. It sits on a poured-concrete foundation, is clad in vertical wood boards, and is topped by a flat built-up roof with no eave (Figures 7.2-55–7.2-57).

The building's facade includes an entry at the northwest corner, comprising a glazed pedestrian door paired with a wall of metal-frame windows supported by a central stiffener. Telescoping bays to the east are also filled by deep set windows in wood frames. The building's secondary east elevation includes a recessed mass to the south that includes drive-thru bays. The roof with deep awning is supported by heavy rectangular posts. Building corners are rounded and no fenestration is present. The building's south elevation provides four drive-thru bays, one of which includes an automated

teller machine. Another includes a callbox. Signage for "Key Bank" is located on the eave. The building's west elevation includes a curved wall surface and the recessed wall of the telescoping entry, with a wall of windows obscured by mature foliage.

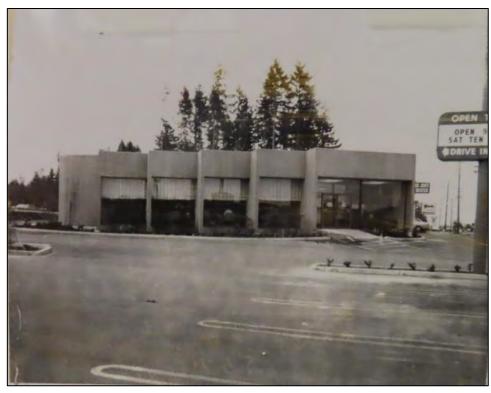
Figure 7.2-57. 32400 Pacific Highway South, undated, King County Assessor, courtesy of the Puget Sound Regional Branch of the Washington State Archives.

From its period of construction (1974), the bank building at 32400 Pacific Highway South retains integrity of location, setting, feeling, and association. According to the King County Assessor, a new teller window and four drive-thru lanes (replacing three earlier lanes) were constructed against the rear (south) elevation of the preexisting bank in 1983, when the building was associated with Puget Sound National Bank (King County Assessor 1935–2022; Seattle Times 1973). Awnings, which provided some screening for original windows on the facade, have been removed, as has freestanding signage, diminishing the building's integrity of design, materials, and workmanship.

As an example of a Modern bank building, HRA recommends the building at 32400 Pacific Highway South eligible for local listing in the NRHP under Criterion C, in the area of Architecture. Its period of significance dates to its construction in 1974, and HRA assumes the boundary of the eligible resource is the current tax parcel boundary.

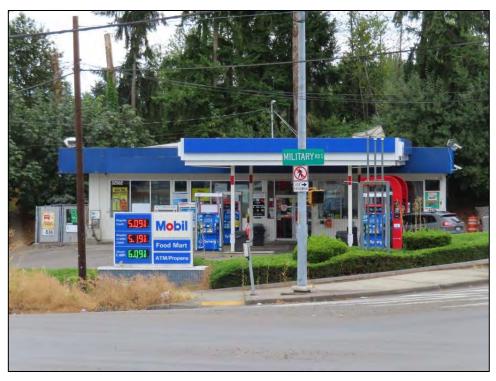
The building's facade faces northwest toward the canopy. It includes an off-center entry of paired aluminum-frame doors topped by sidelight and flanked east and west by ribbons of half-height, aluminum-frame windows. The secondary east elevation includes no fenestration. The secondary west elevation includes one large picture window paired with a ribbon of shallow windows. Freestanding signage identifies the business as a Mobil gas station.

Figure 7.2-58. 32002 Military Road South, view southeast.

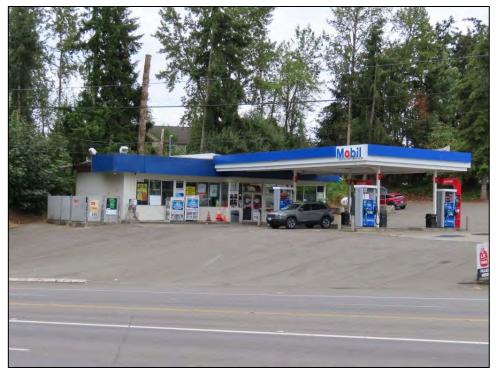
Figure 7.2-59. 32002 Military Road South, view south.

According to the King County Assessor, the gas station and market at 32002 Military Road South was constructed in 1973 (King County Assessor 1935–2022). The single-story building is rectangular in plan with a projecting canopy supported by slender posts over gas pumps. The building sits on a poured-concrete foundation, is of prefabricated metal clad in wood sheet, and is topped by a flat, built-up roof with deep projecting eave (Figures 7.2-58–7.2-60).

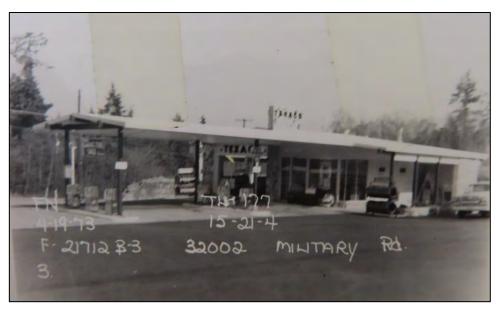
Figure 7.2-60. 32002 Military Road South, 1973, King County Assessor, courtesy of the Puget Sound Regional Branch of the Washington State Archives.

From its period of construction (1973), the market and gas station at 32002 Military Road South retains integrity of location, setting, and feeling, as it remains on its original parcel. A review of assessor's photos indicates that the canopy has been rebuilt as a flat rather than gabled shelter; the building's character-defining blade sign has been removed; and the building's once asymmetrical entrance has been redesigned to feature bands of symmetrical windows (King County Assessor 1935–2022). The building has been rebranded as a market and gas station. The building no longer retains integrity of design, materials, workmanship, or association.

Due to a lack of significance and loss of integrity, HRA recommends 32002 Military Road South not eligible for listing in the NRHP under any criteria.

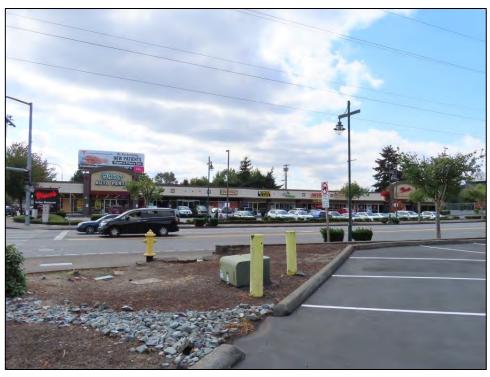
Figure 7.2-61. 32411 Pacific Highway South, view southwest.

According to the King County Assessor, the strip commercial building at 32411 Pacific Highway South was constructed in 1972 (King County Assessor 1935–2022). The single-story building is generally rectangular and faces north. It sits on a poured-concrete foundation, is constructed of concrete block, and is topped by a flat, built-up roof with two prominent parapets near the east and west corners of the north-facing facade (Figures 7.2-61–7.2-63).

The building includes two large retail spaces, defined by enframed entries with projecting columns and large parapets for signage. Tenants include O'Reilly Auto Parts (east) and Vince's Italian Restaurant (west). Below the parapets and across the facade are storefronts made up of aluminumframe pedestrian doors flanked by full-height, aluminum-frame windows and topped by transoms, some of which have been covered with panels of textured concrete. Storefronts are separated by concrete-block columns, and the facade steps back slightly from the anchor tenant at the northeast corner. Above the storefronts, the eaves include lighted signage and some ornamental concrete projections. The building's secondary west elevation includes wrapping windows from the facade and one secondary pedestrian door. The rear (south) elevation includes a wall of concrete block with secondary pedestrian doors and a projection off the easternmost tenant space. The building's east elevation includes wrapping windows from the facade and a stepped-back wall of parged-concrete block and concrete planter boxes.
