Federal Way City Center Access Project Cultural Resources Technical Report

Submitted to: Washington State Department of Transportation

Submitted by: Historical Research Associates, Inc. Matthew Warren, PhD Chrisanne Beckner, MS

> Seattle, WA December 2022

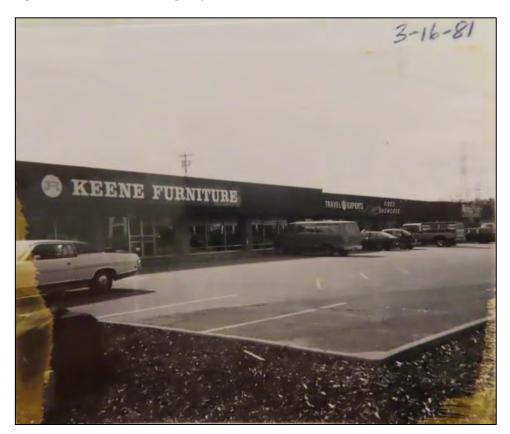
Figure 7.2-63. 32411 Pacific Highway South, 1981, King County Assessor, courtesy of the Puget Sound Regional Branch of the Washington State Archives.

From its period of construction (1972), the strip commercial building at 32411 Pacific Highway South retains integrity of location, setting, and association, as it continues to host numerous business storefronts off Pacific Highway South. Alterations associated with a 6,000 square ft addition in 1980 and extensive exterior remodeling as recently as 2005 have obscured the facade's historical character and diminished its integrity of design, materials, workmanship, and feeling (King County Assessor 1935–2022; Seattle Times 1980).

Due to a lack of significance and an irretrievable loss of integrity, HRA recommends 32411 Pacific Highway South not eligible for listing in the NRHP under any criteria.

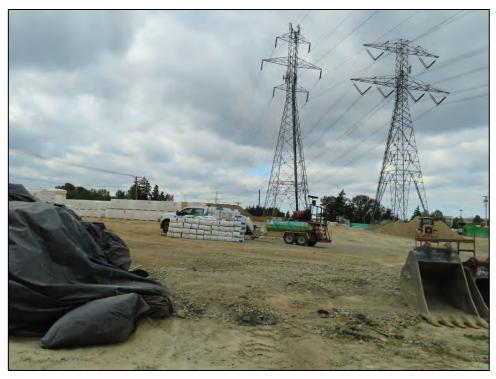
Initial research indicated that a single-family residence was located at 3014 South 320th Street However, field survey indicated that the building had been demolished, and this parcel and surrounding parcels were under development. No historic-period resource was present (Figures 7.2-64).

Figure 7.2-64. The former location of 3014 South 320th Street, view west.

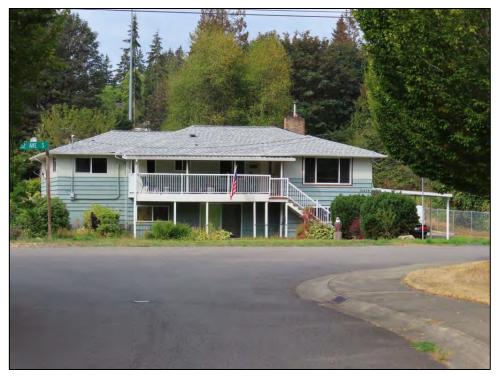
Figure 7.2-65. 31209 32nd Avenue South, view west.

According to the King County Assessor, the residence at 31209 32nd Avenue South was constructed in 1954 (King County Assessor 1935–2022). However, it appears that the 1950s building was moved to this location in 1969, as suggested by property records cards and historic aerial imagery (King County Assessor 1935–2022; NETROnline 2022). The parcel at 31209 32nd Avenue South remained undeveloped in 1969, according to aerial imagery, and the extant residence appears at its present location and in its present form by 1980 (NETROnline 2022). The two-story building, irregular in plan, faces east. It sits on a concrete-block foundation, is clad in a combination of lapped wood boards topped by T1-11, and is topped by a hipped asphalt shingle roof (Figures 7.2-65–7.2-67).

The building's east-facing facade includes a prominent deck with metal railing off the upper story. It is accessed by a stair with metal rail, is supported by slender posts, and provides access to the primary entry door, which is flanked to the north by a projection with vinyl-frame windows. To the south are additional vinyl-frame windows, and a recessed mass on the south end with a vinyl-frame window. Under the balcony is a sliding door and additional vinyl windows. The building's secondary elevations are minimally visible. The north elevation includes a projecting carport with vehicular access to a large garage located west of the residence. It is front gabled and clad in wood boards topped by T1-11. The secondary south elevation includes two additional sliding, vinyl-frame windows. To the rear of the building is a large greenhouse next to the garage. According to the King County Assessor, the greenhouse and a shed, not visible from the public ROW, were added in 2016 (King County Assessor 1935–2022).

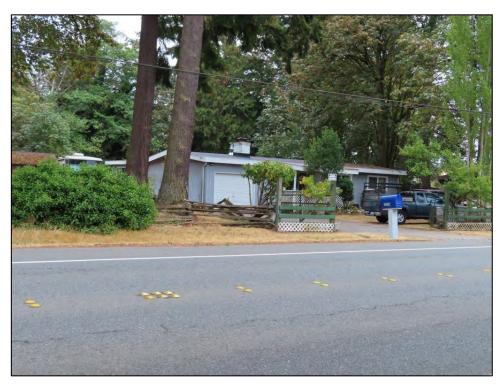
Figure 7.2-68. 31014 28th Avenue South, view southeast.

According to the King County Assessor, the residence at 31014 28th Avenue South was constructed in 1957 (King County Assessor 1935–2022). The single-story building is rectangular in plan and faces west. It sits on a poured-concrete foundation, is clad in T1-11, and is topped by a side-gabled, membrane roof (Figures 7.2-68-7.2-70).

The building's west-facing facade includes a central entry flanked north and south by vinyl-frame windows. The entry and the three-part window to its north are paired with a wood deck with wood lattice railing, topped by a projecting porch roof of corrugated plastic supported by slender square posts. Additional vinyl-frame sliding windows are located to the south, and an overhead garage door is located to the north. Privacy fencing and mature foliage screen the house from the roadway and secondary elevations are not visible.

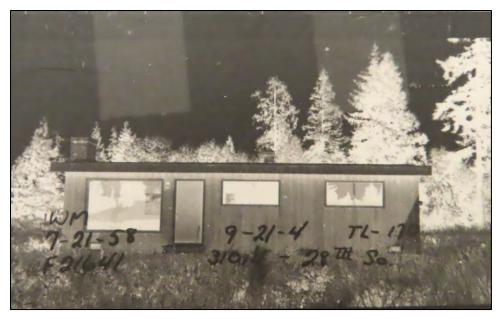
Figure 7.2-70. 31014 28th Avenue South, 1958, King County Assessor, courtesy of the Puget Sound Regional Branch of the Washington State Archives.

From its period of construction (1957), the residence at 31014 28th Avenue South retains integrity of location, setting, feeling, and association, as it remains a single-family residence on its original parcel. The addition of an attached garage and porch, along with alterations and incompatible replacement materials, including windows, have diminished its integrity of design, materials, and workmanship.

Due to a lack of significance and an irretrievable loss of integrity, HRA recommends 31014 28th Avenue South not eligible for listing in the NRHP under any criteria.

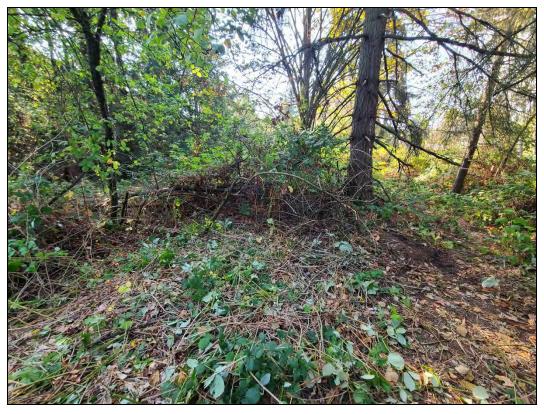
Buried asphalt road surface of Site 45KI1662, view south along site alignment.

HRA archaeologists encountered one historic-period archaeological site, a mid-twentieth century abandoned asphalt roadway. The site was assigned the Smithsonian trinomial 45KI1662. HRA recommends that the site is not eligible for listing in the NRHP. Site 45KI1662 does not meet any of the criteria for listing in the NRHP, and it lacks integrity of design, workmanship, feeling, and association. No other significant archaeological resources were identified within the ADI.

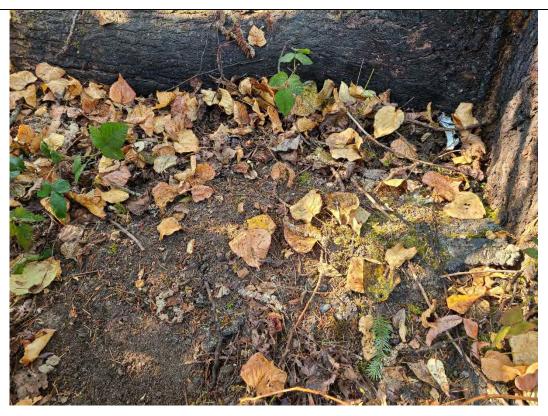
Asphalt road surface of Site 45KI1662 exposed due to root growth disturbance.

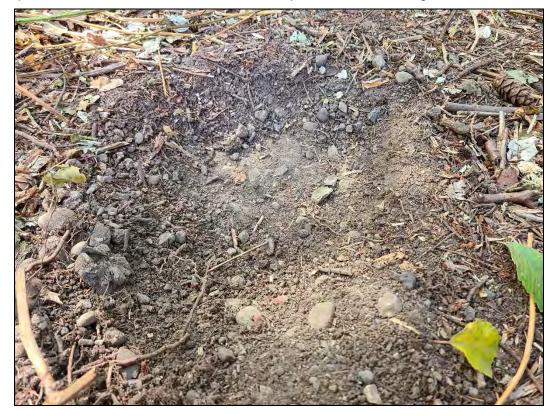
Asphalt road surface exposed in shovel probe.

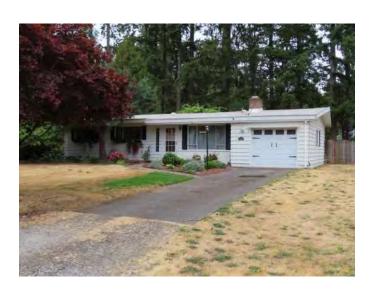
Address: 3812 S 321st St, Federal Way, Washington, 98001

Category	Item	
Plan	Rectangle	
Foundation	Concrete - Poured	
Form Type	Single Dwelling	
Roof Type	Gable - Side	
Roof Material	Asphalt/Composition - Built Up	
Cladding	Wood - Clapboard	
Structural System	Wood - Platform Frame	
Styles:		
Period	Style Details	
No Style	No Style

According to the King County Assessor, the residence at 3812 S 321st St. was constructed in 1959 (King County Assessor 1935–2022). The single-story building faces south toward 321st St. It is rectangular in plan, sits on a poured-concrete foundation, is clad in lapped wood boards, and it topped by a side-gabled membrane roof.

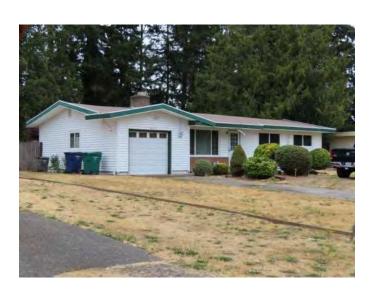
Address: 3820 S 321st St, Federal Way, Washington, 98001

Category	Item
Foundation	Concrete - Poured
Form Type	Single Dwelling
Roof Type	Gable - Cross
Roof Material	Asphalt/Composition - Built Up
Cladding	Vinyl Siding
Structural System	Wood - Platform Frame
Plan	L-Shape
Styles:	
Period	Style Details
No Style	No Style

According to the King County Assessor, the residence at 3820 S 321st St. was constructed in 1959 (King County Assessor 1935–2022). The single-story, L-shaped building faces south. It sits on a poured-concrete foundation, is clad in vinyl siding, and is topped by a cross-gabled, membrane roof.

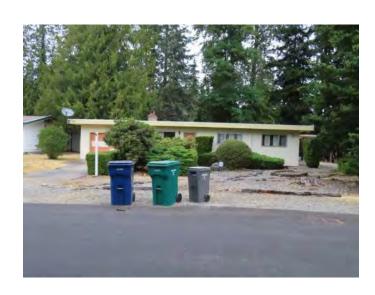
Address: 3828 S 321st St, Federal Way, Washington, 98001

Category	Item
Foundation	Concrete - Poured
Form Type	Single Dwelling
Roof Type	Flat with Eaves
Roof Material	Asphalt/Composition - Built Up
Cladding	Wood - Vertical Boards
Structural System	Wood - Platform Frame
Plan	Rectangle
Styles:	
Period	Style Details
No Style	No Style

According to the King County Assessor, the residence at 3828 S 321st St. was constructed in 1959 (King County Assessor 1935–2022). The single-story, rectangular building faces south. It sits on a poured-concrete foundation, is clad in wood sheet, and is topped by a flat roof with deep eave.

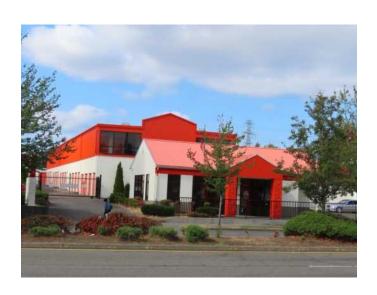
Address: 32615 Pacific Hwy S, Federal Way, Washington, 98003

From its period of construction (1975), the warehouse complex at 32615 Pacific Highway S retains integrity of location and setting, as it remains on its original parcel on Pacific Highway S. The complex does not retain integrity of design, materials, workmanship, feeling, or association due to extensive alterations and additions that included the replacement of the original office building ca. 2006 (King County Assessor 1935–2022; NETROnline 2022).

According to the King County Assessor, and confirmed by aerial photography, the 19 commercial warehouses and a former office building at 32615 Pacific Highway S were constructed in 1975 (King County Assessor 1935–2022; NETROnline 2022). The original office building was replaced by a new office building ca. 2006 (NETROnline 2022). The development faces east toward Pacific Highway S. The office is a small rectangular building separated from a large warehouse to the rear (west) by a drive. These buildings are flanked by one additional warehouse to the north and south, with a grid of 16 additional warehouses located to the rear of the large parcel. Warehouses and office are located on poured-concrete foundations, are constructed of concrete, and include upper panels of corrugated metal siding. The office is topped by a side-gabled, standing-seam metal roof with minimal eaves. The warehouses are topped by flat built-up roofs.

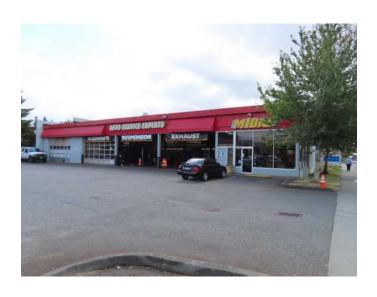
Address: 32530 Pacific Hwy S, Federal Way, Washington, 98003

From its period of construction (1975), the building at 32530 Pacific Highway S retains integrity of location, setting, design, materials, workmanship, feeling, and association, as few alterations are evident apart from the replacement of one glass pedestrian door with a solid door and the removal of freestanding signage, evident in assessor's photos (King County 2022).

According to the King County Assessor, the automotive service center at 32530 Pacific Highway S was constructed in 1975 (King County Assessor 1935–2022). The building is a single story tall, rectangular in plan, and faces a parking lot to the north. The building sits on a poured-concrete foundation, is constructed of concrete block, and is topped by a flat built-up roof with parapet.

The building's facade includes an aluminum-frame pedestrian door surrounded by aluminum-frame full-height windows and transoms that wrap the building's northwest corner. East of the entry is a secondary aluminum-frame door with sidelight and transom. Farther east are four garage bays with overhead garage doors. Visible garage doors are metal with lights. The garage bays are partially topped by shallow awnings, broken by a sign for "Auto Service Experts." The building's west elevation includes corner-wrapping windows near the entry but no other fenestration. The south elevation abuts another building and was not visible. The east elevation includes a projecting end wall but was not visible.

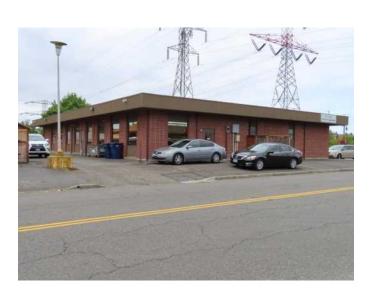
Address: 1617 S 324th St, Federal Way, Washington, 98003

From its period of construction (1971), the building at 1617 S 324th St. retains integrity of location, setting, design, materials, workmanship, feeling, and association, as no alterations were evident, apart from some in-kind window replacement.
