Geotechnical Engineering Services Report

Weyerhaeuser Way South, 320th Street to SR 18
Weyerhaeuser Campus Property
Federal Way, Washington

August 29, 2017

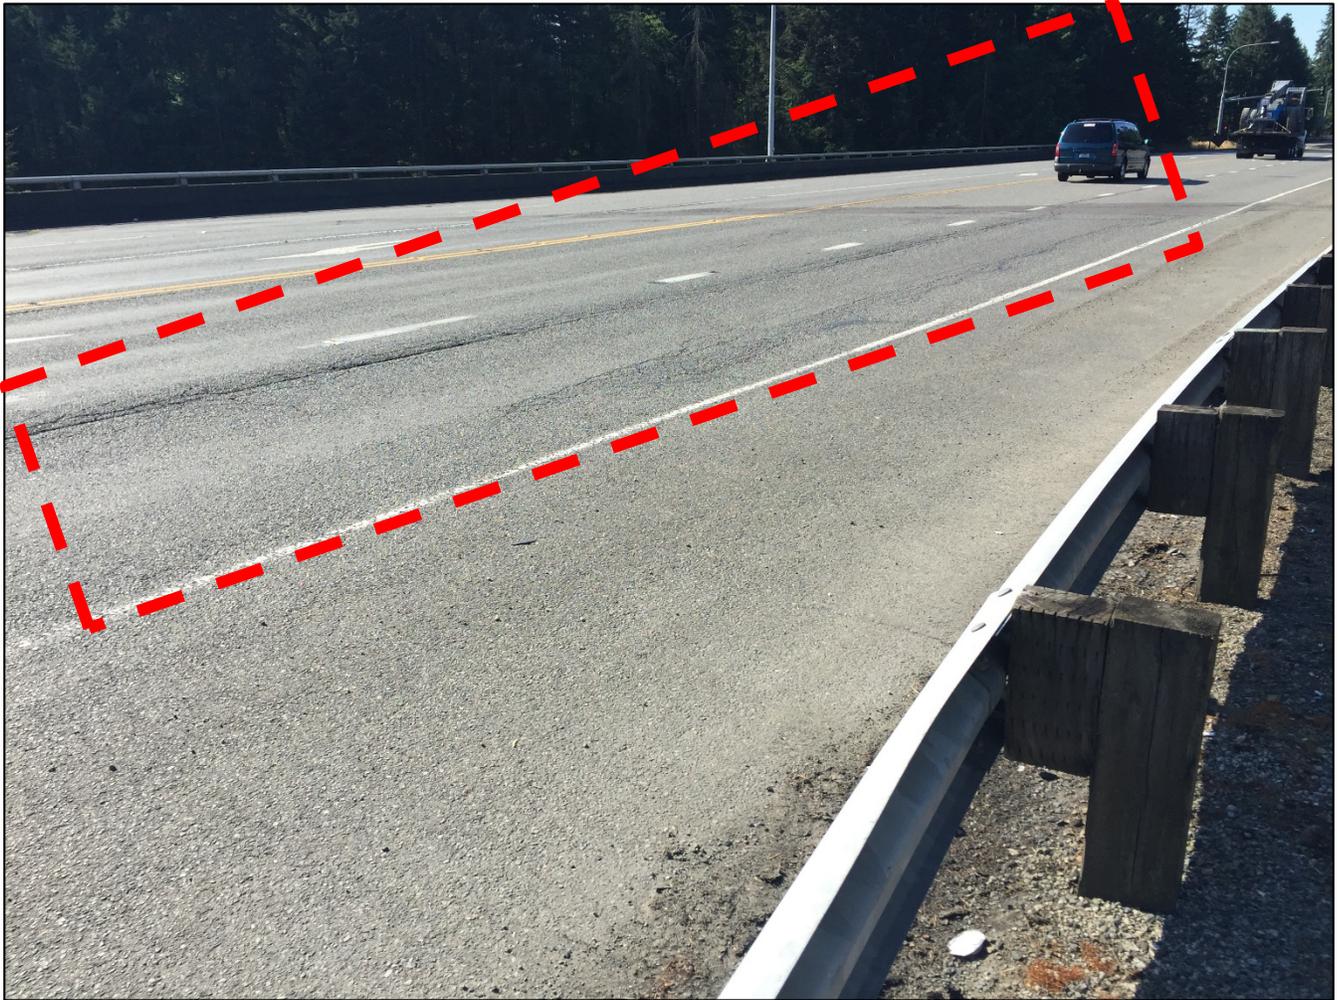
Figure B-1

Observed Distress
<ul style="list-style-type: none"> ■ Low to severe fatigue cracking* ■ Low depression ■ Low to severe longitudinal and transverse cracking* ■ Low to moderate patch deterioration ■ Low to moderate potholes* ■ Moderate rutting near storm drain*

**Pavement Distress Photo:
Fatigue Cracking of AC Pavement**

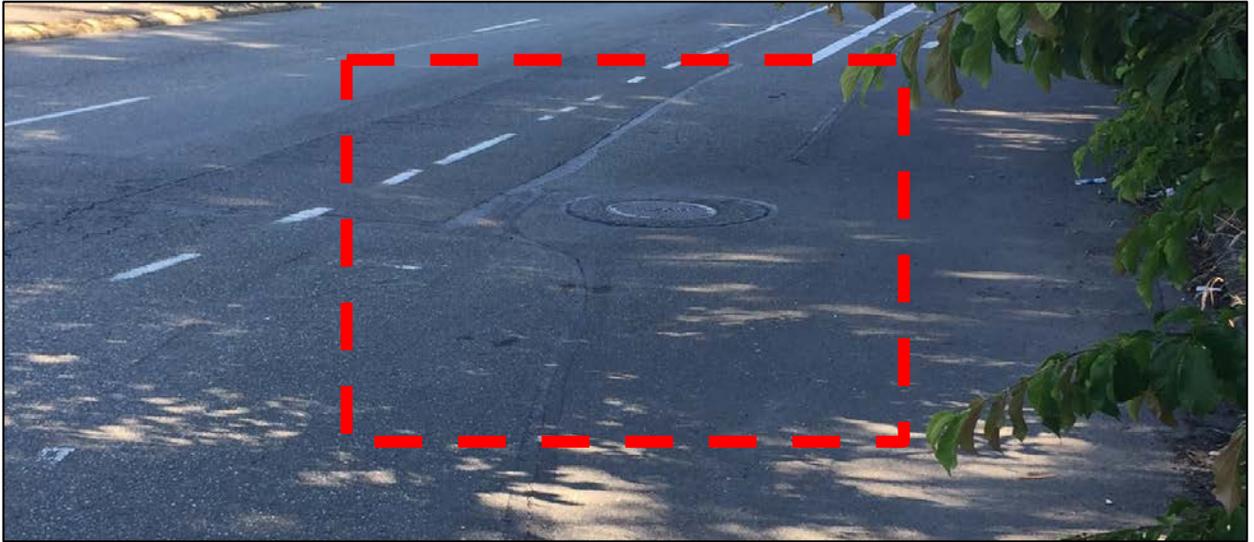
Little to no rutting was observed with exception of the pavement surrounding a manhole located about 150 feet north of the eastbound off-ramp in the right-hand turn lane. Moderate to severe rutting was observed in this area. The rutting surrounding the manhole is likely due to deeper depths of under compacted fill, leading to isolated settlement of the pavement subgrade in these areas.

**Pavement Distress Photo:
Rutting/Settlement**

Prior to an overlay, we recommend that that highly deteriorated pavement sections and sections with ruts receive a full depth replacement following our recommendations for Alternative 1. Based on our visual assessment we expect that most of these full depth repairs will occur in 2-foot wide segments in the wheel tracks. We recommend that for preliminary budgeting purposes you assume that about 2,500 linear feet of wheel track (about 5,000 square feet) will need to be repaired. Actual repair limits should be based on a more detailed evaluation of the pavement condition just prior to construction.
