Introduction

Survey

Steel Lake Aquatic Plant Survey, June 2023

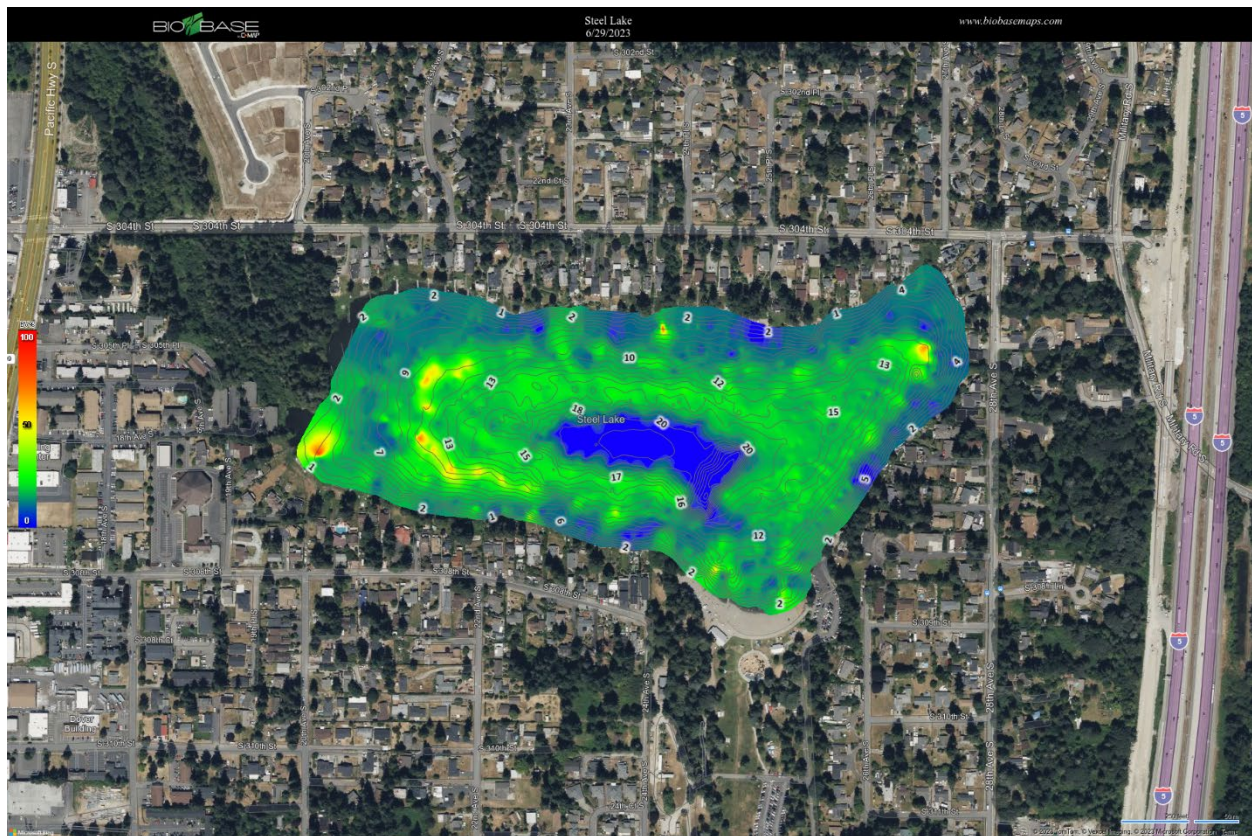
June 2023 Aquatic Plant Biovolume map

The color ramp shows aquatic plant biovolume or the percent of the water column filled with aquatic vegetation. Blue equals no plants present, greens in the 30-60 percent range, yellows and oranges in the 60-80 percent range and red 100 percent.

At the point of this survey and well into the summer growing season, there were no areas of the lake where aquatic plant growth was approaching a “weed problem”. The aquatic vegetation analysis report can be viewed at this link: [Vegetation Analysis Report \(2023 August 16 - 17:02 \(UTC\)\) \(s3-nox-prd-processing-snr-rpt-use1.s3.amazonaws.com\)](https://s3.amazonaws.com/s3-nox-prd-processing-snr-rpt-use1.s3.amazonaws.com/Vegetation%20Analysis%20Report%20(2023%20August%2016%20-%2017:02%20(UTC)).pdf)

While significant areas of the lake bottom supported aquatic plant growth very little of that growth was approaching the lake surface where it would interfere with beneficial uses.

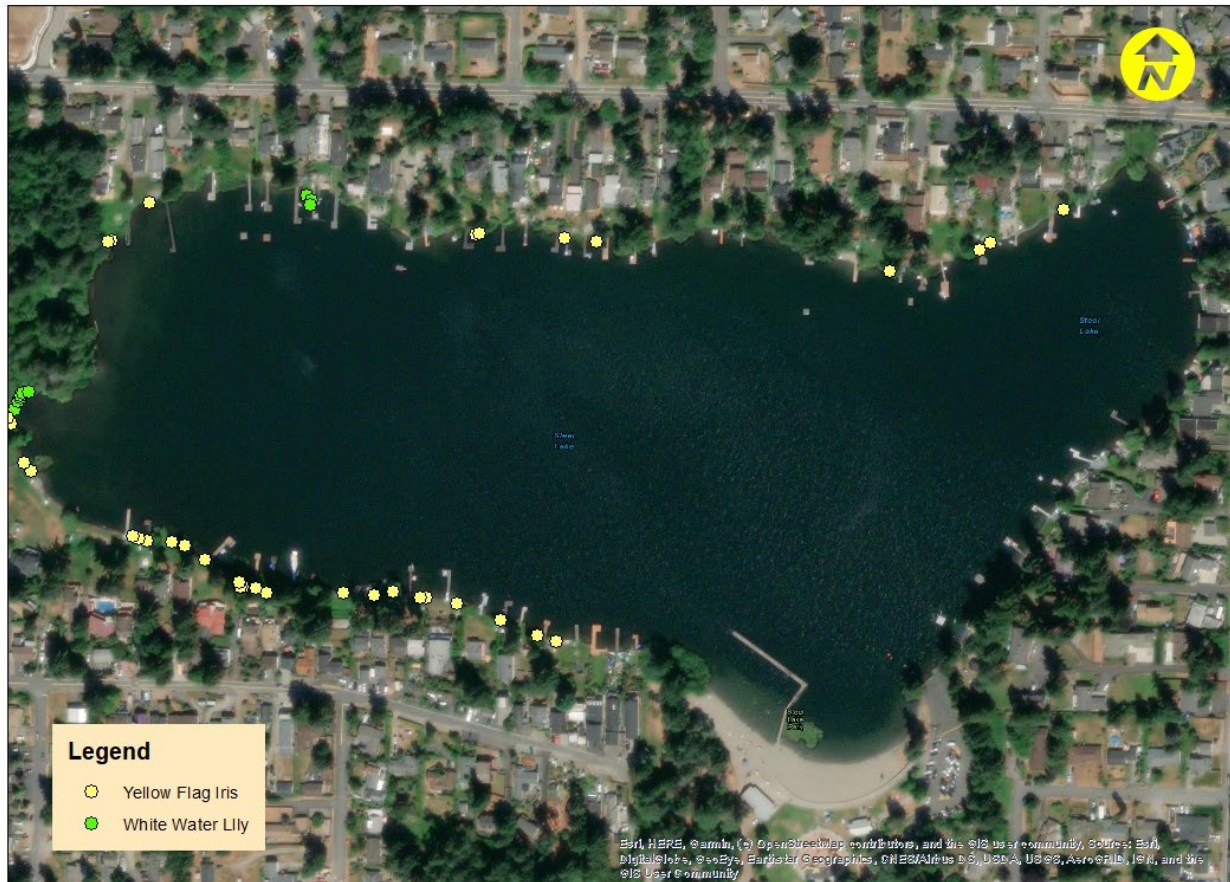
Steel Lake, June 2023

The map above shows the emergent and floating Noxious Weeds observed on the shoreline. No purple loosestrife was observed by our biologists, a second survey in August or September could be to determine if there are treatment needs for Loosestrife.

There continues to be scattered populations of Yellow Flag Iris around the margins of the lake as shown on the map above. One issue however is that the remaining Yellow Flag Iris is present in lake residents landscape. The plants are generally single plant communities in the residents' lawns. Treating these would require permission and careful application as treatment crews would be working on private property.

In previous years some of the Lake Management District residents did not want to have applications made on their property and the City had provided us with maps each year where permission was available to treat. We used this information to target this growth. There used to be a map of those properties. Much of the growth present is well into the property and landscape and applicators will have to enter these properties in most cases to reach these plants. This should be an objective of the LMD for future work targeting this weed.

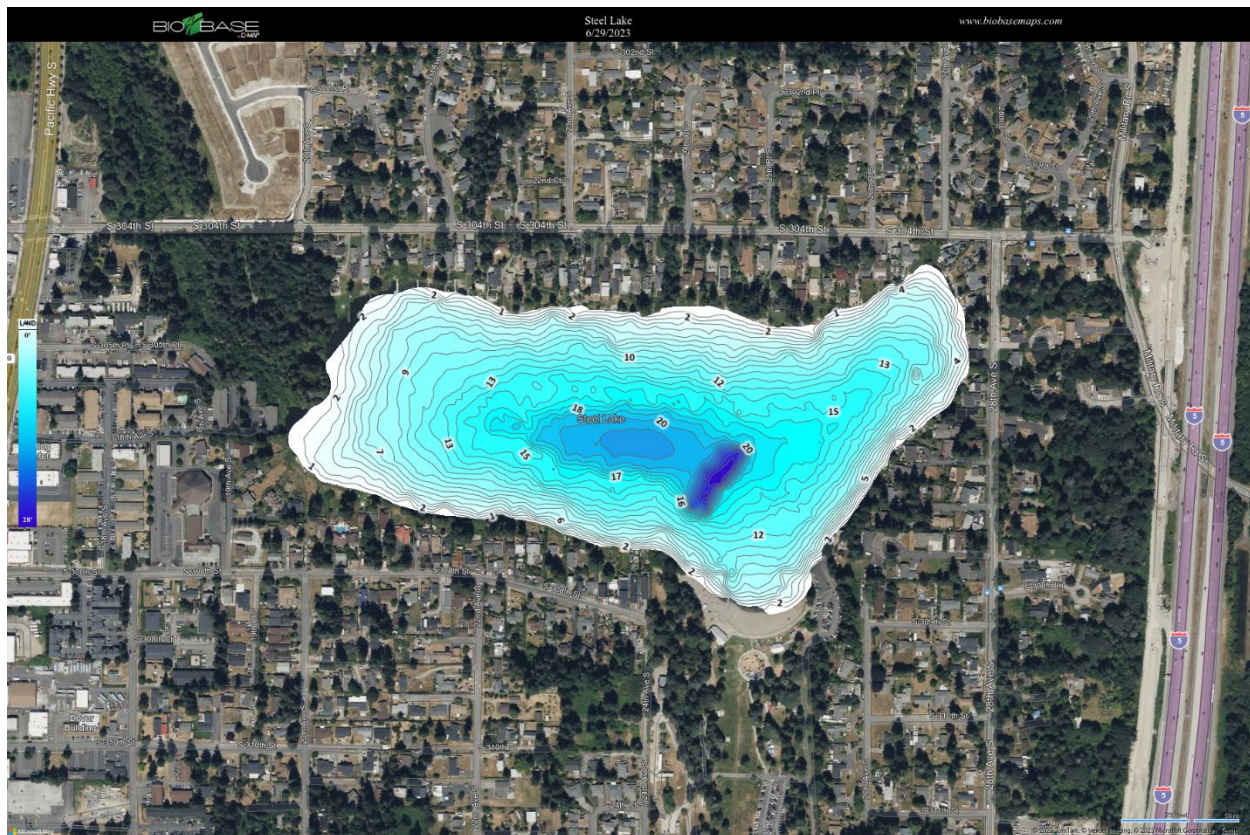
Steel Lake Bathymetry, June 2023

The BioBase system creates two additional maps, one of lake bathymetry and one of lake sediment composition. The bathymetry map is useful to calculate lake volume and to generally show the shape of the lake bottom. The lake sediment map is useful to look at accumulations of organic matter, the softer the sediment layers the more organic matter present as a general rule.

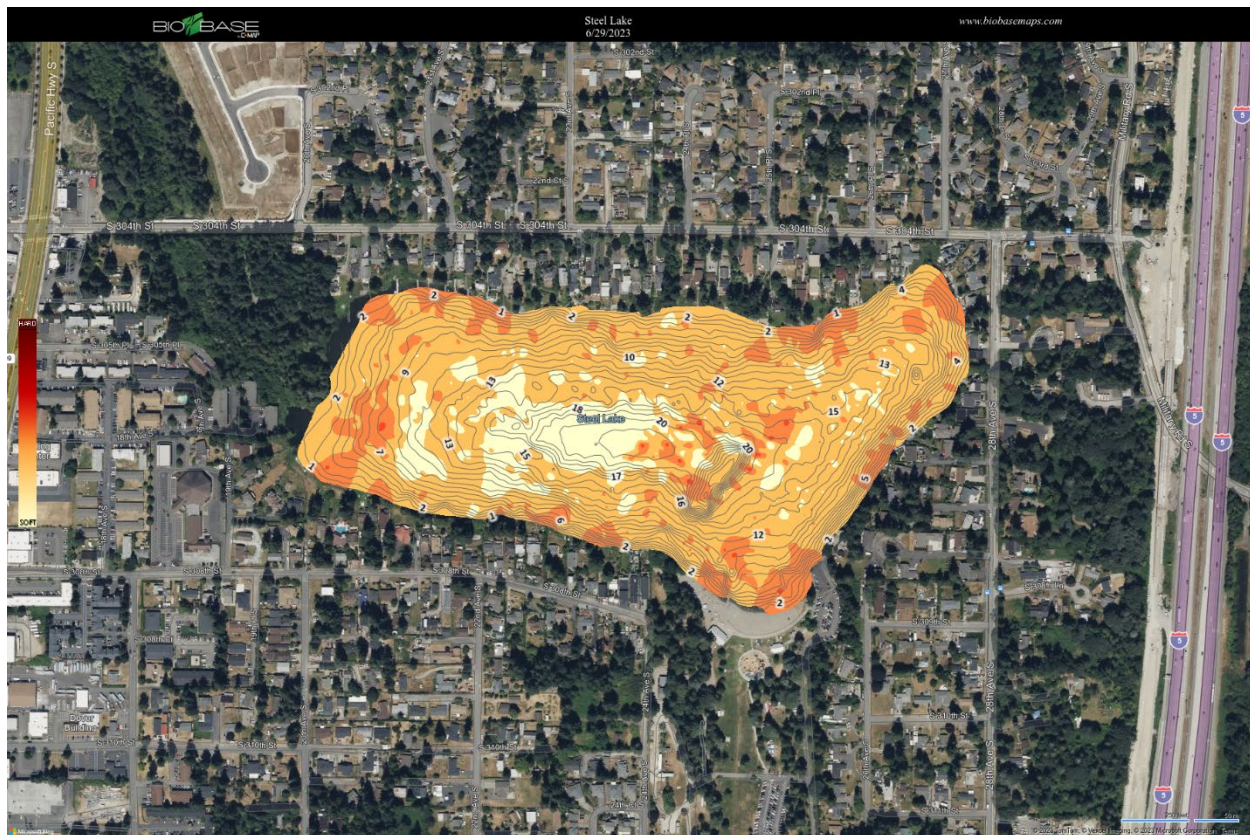
Steel Lake Sediment Composition June 2023

The lake sediment composition map can be viewed and analyzed using the color ramp on the left of the image. The top darker colors represent hard bottom and generally rock, the light color on the bottom indicates very soft organic sediments are present.
